**CONSENT ORDER
ISSUED UNDER THE
WATER POLLUTION CONTROL ACT
WEST VIRGINIA CODE, CHAPTER 22, ARTICLE 11**

TO: MarkWest Liberty Midstream & Resources, L.L.C. DATE: March 28, 2019
Gregory Bezdek, SVP, NE Region
4600 J Barry Ct. Ste 500
Canonsburg, PA 15317 ORDER NO.: 8945

MARKWEST LIBERTY MIDSTREAM & RESOURCES, L.L.C, WVR311004, Sherwood to Mobley
20" NGL, 8/22 & 8/23/2018

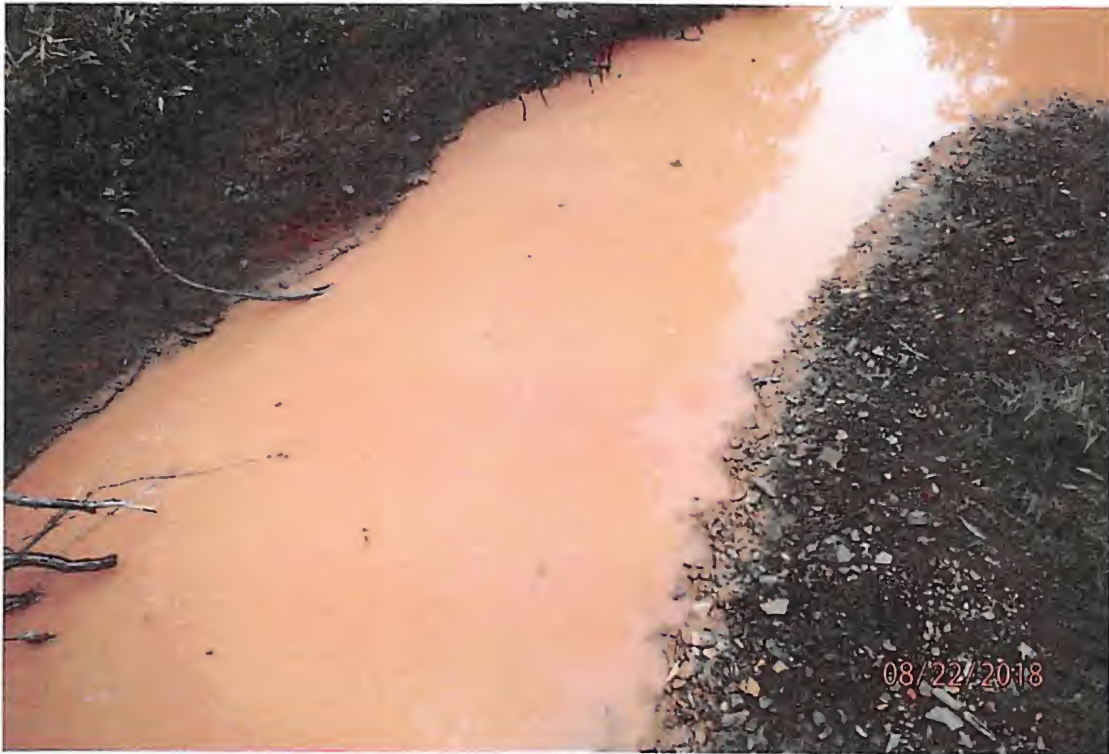
Offsite CNA deposits and distinctly visible settleable solids in UNT Franks Run (39° 26.167' X 80° 36.861') downstream of the dewatering activity.

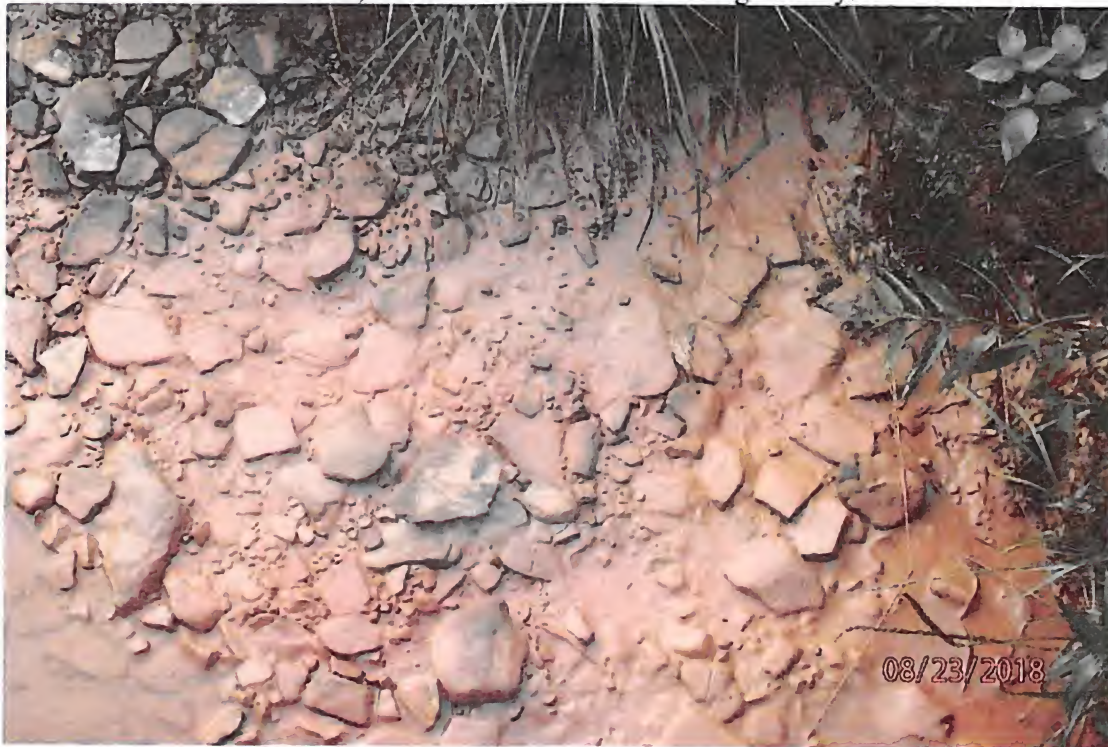
Offsite CNA deposits and distinctly visible settleable solids in UNT Franks Run (39° 26.167' X 80° 36.861') downstream of the dewatering activity.

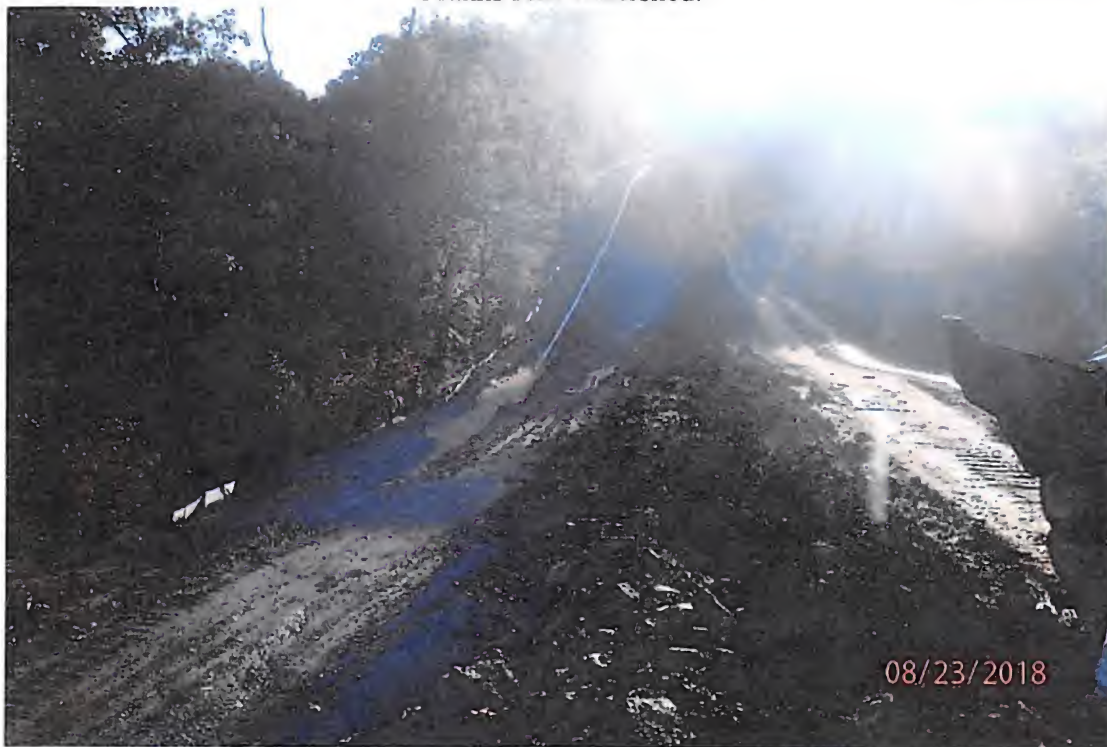
Area of open pipe trench that led to the need for the previously pictured dewatering operation in UNT Franks Run watershed. This area lacked the installed water bars that was described in the approved SWPPP.

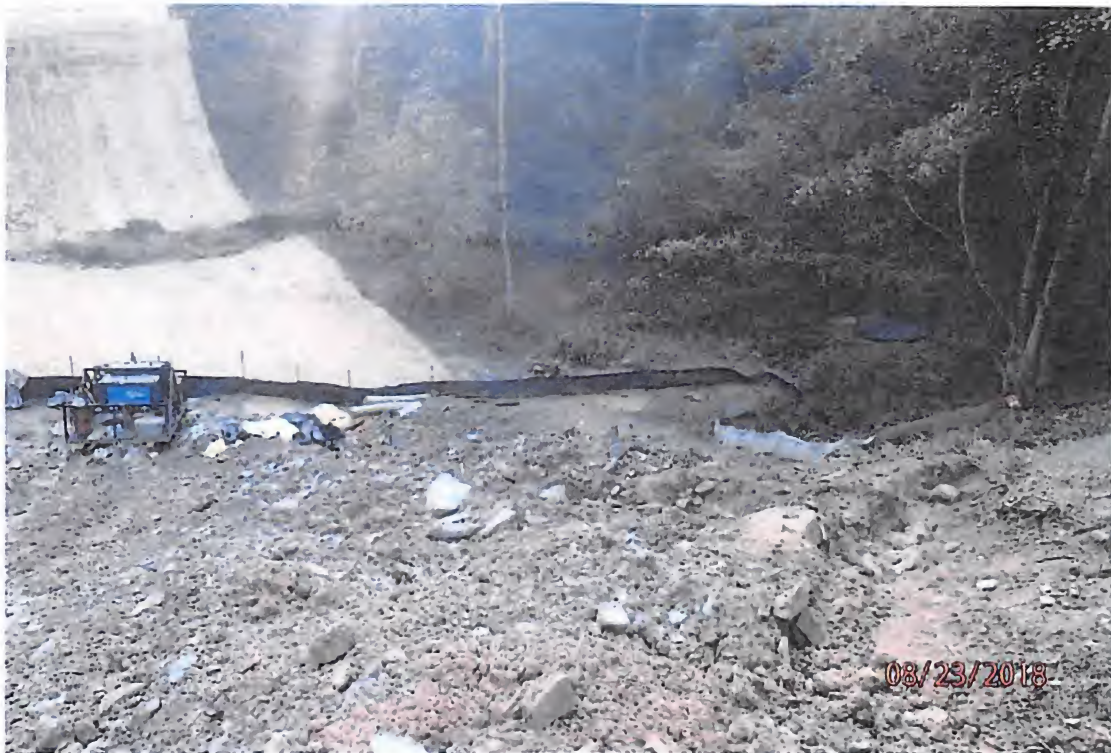
Overview of dewatering adjacent to UNT Beverlyn Fork (UNT129).

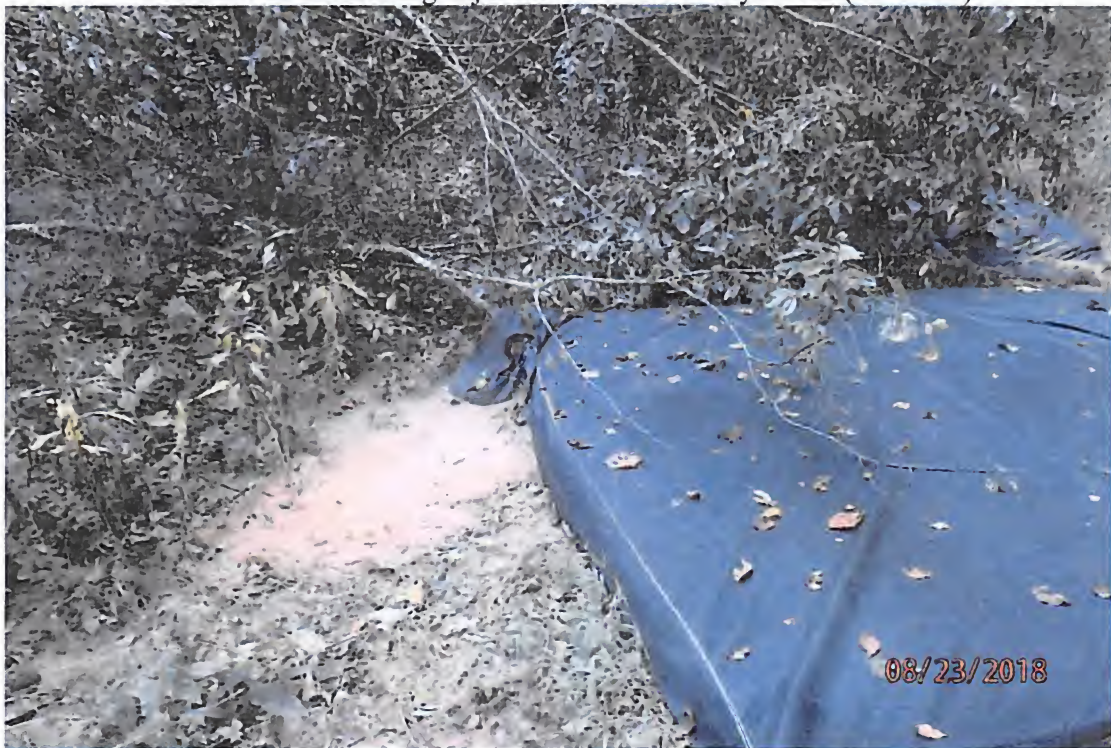
Offsite sediment deposits below dewatering bag that lead to the receiving stream.

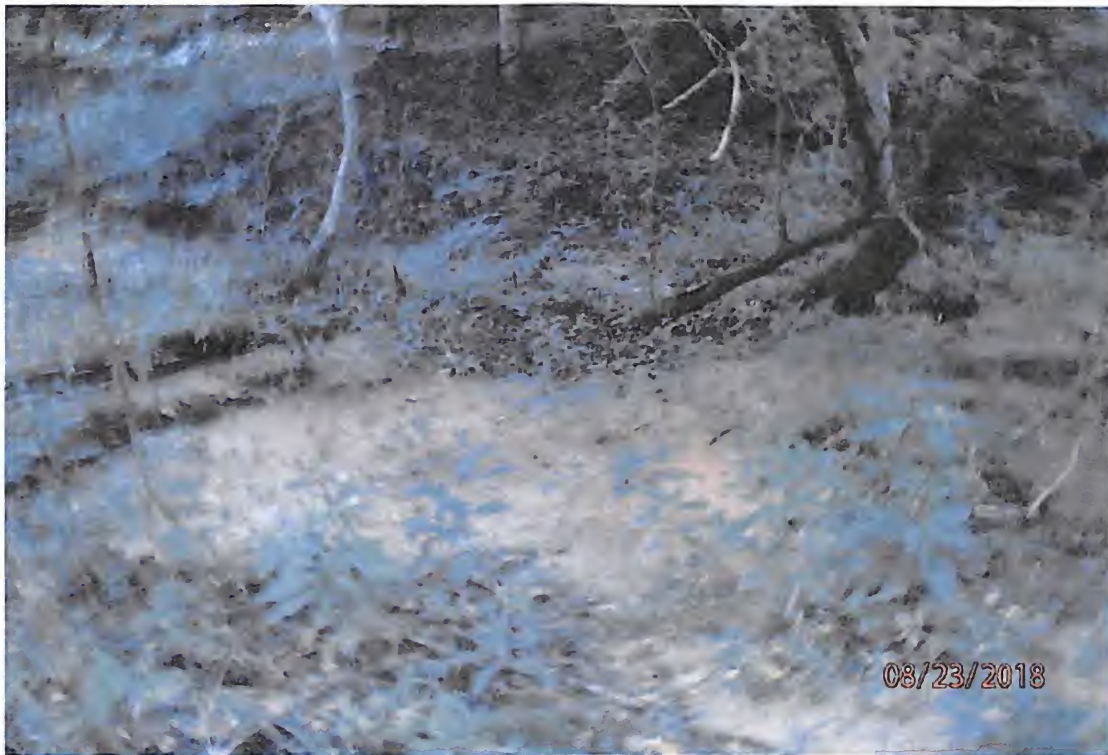
Offsite sediment deposits below dewatering bag that lead to the receiving stream at UNT 129.

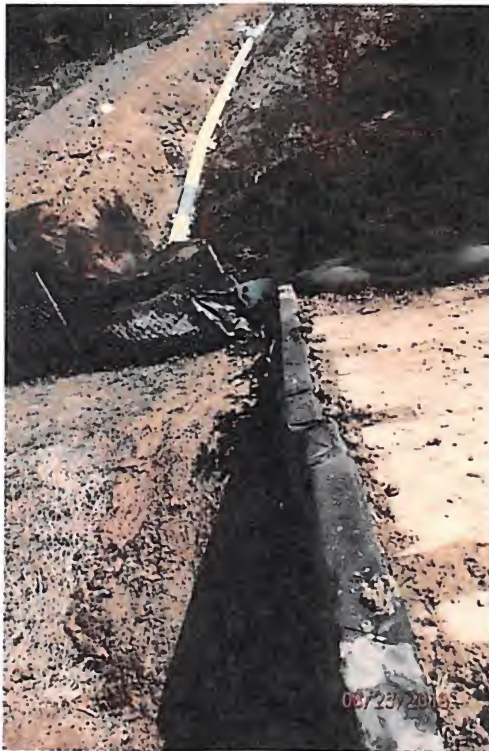
BMPs that were overwhelmed due to flow from the open pipe trench adjacent to crossing #23 (UNT 133).

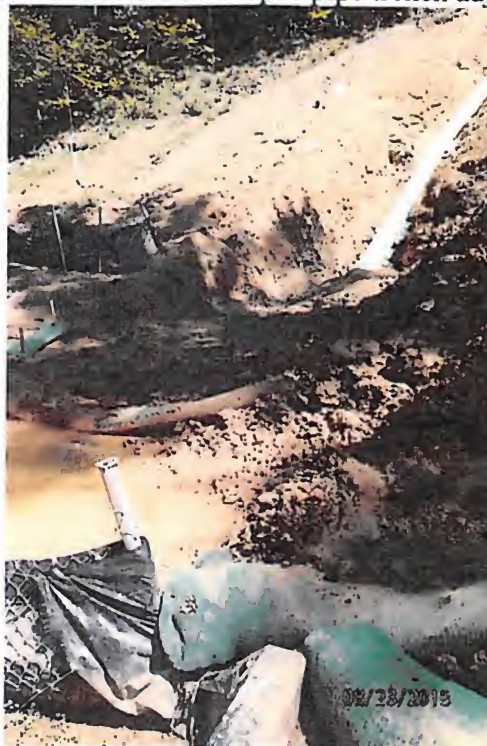
BMPs that were overwhelmed due to flow from the open pipe trench adjacent to crossing #23 (UNT 133) that led to offsite CNA.

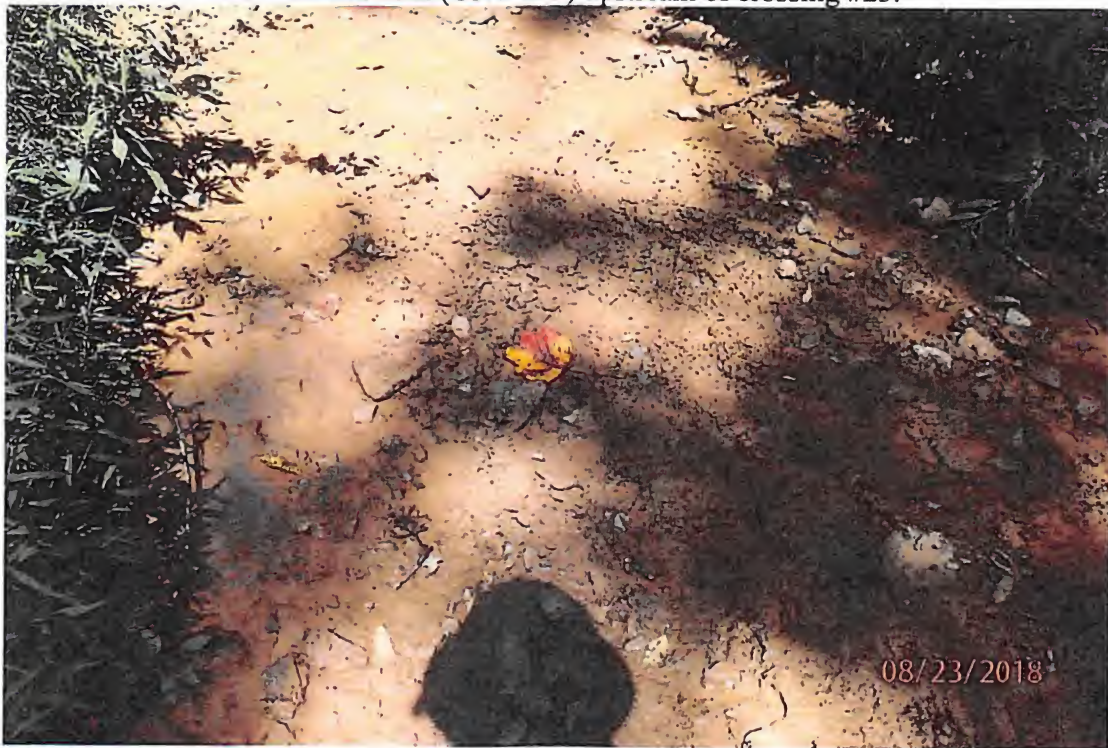
UNT Franks Run (UNT 133) downstream of crossing #23. Offsite CNA deposits in UNT Franks Run (39° 25.885' X 80° 37.133') pictured.

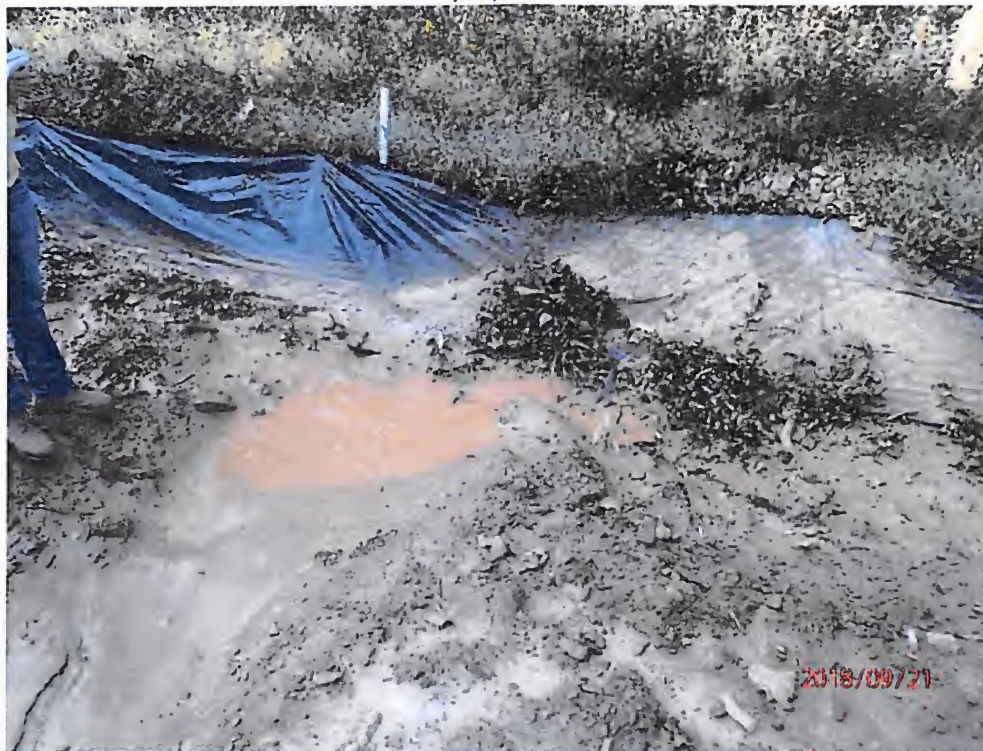
Sediment leaving project through super silt fence in need of maintenance near Archers Fork access.

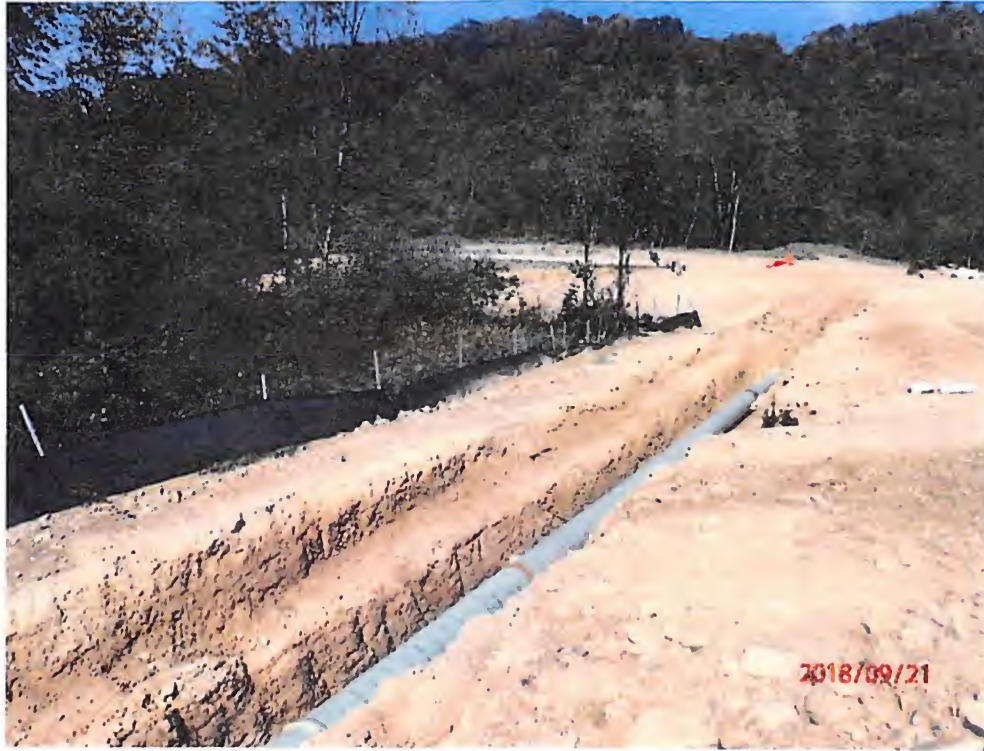
Super silt fence in need of maintenance near Route 20 bore site.

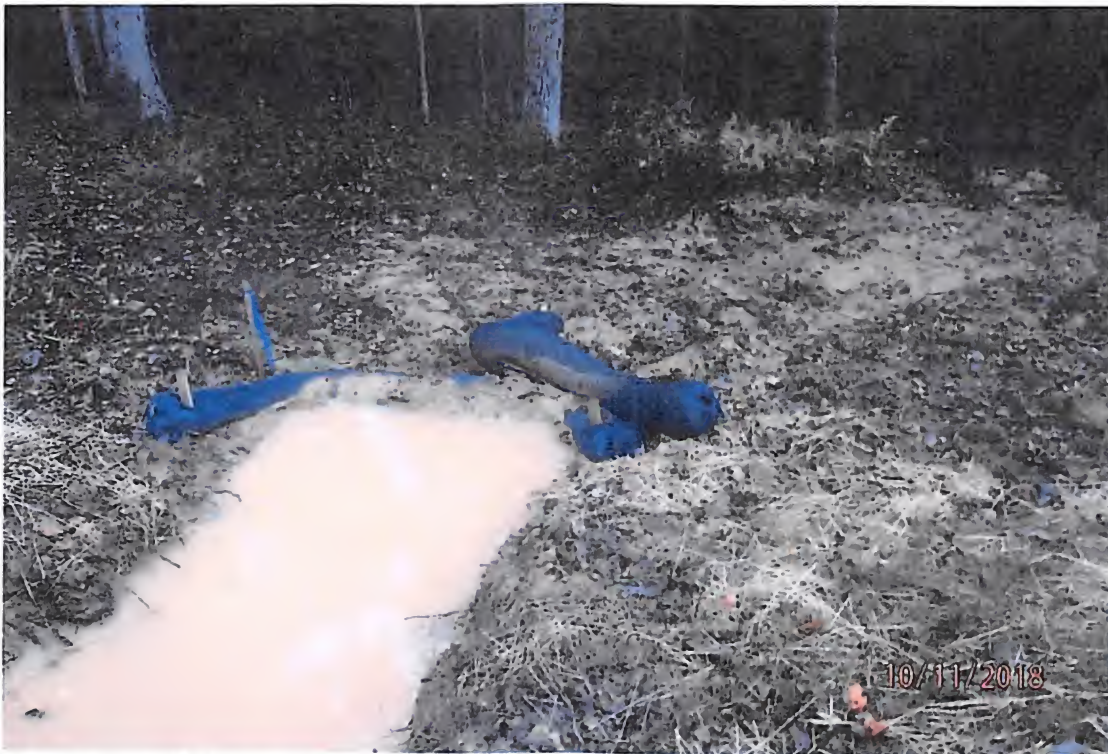
Water bar terminus BMP in need of maintenance and associated offsite sediment deposits in the Riggins Run watershed.

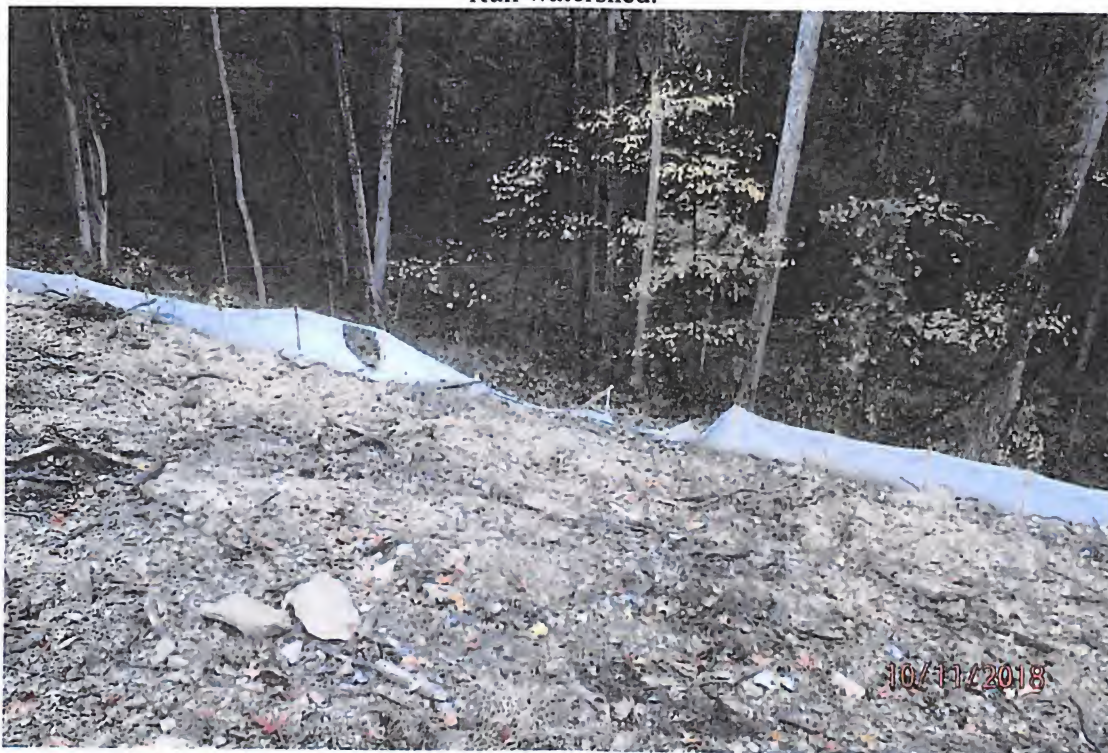
Perimeter control in need of maintenance in the Riggins Run watershed.

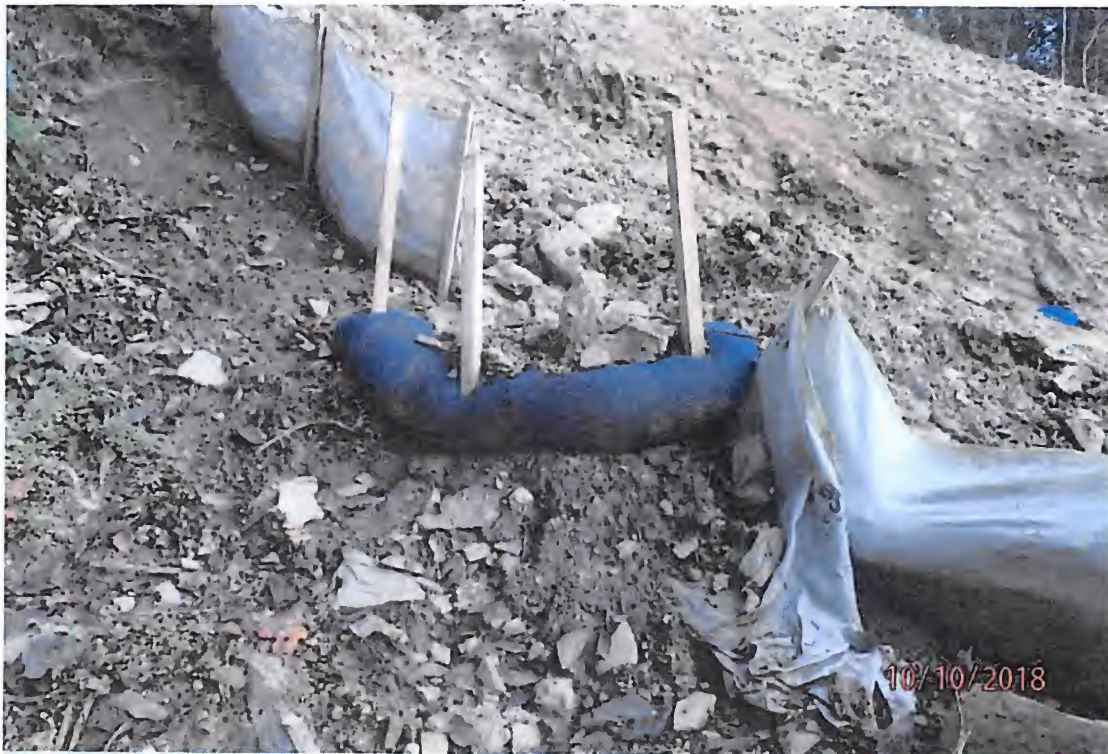
Water bar terminus BMP in need of maintenance in the Buckeye Creek watershed.

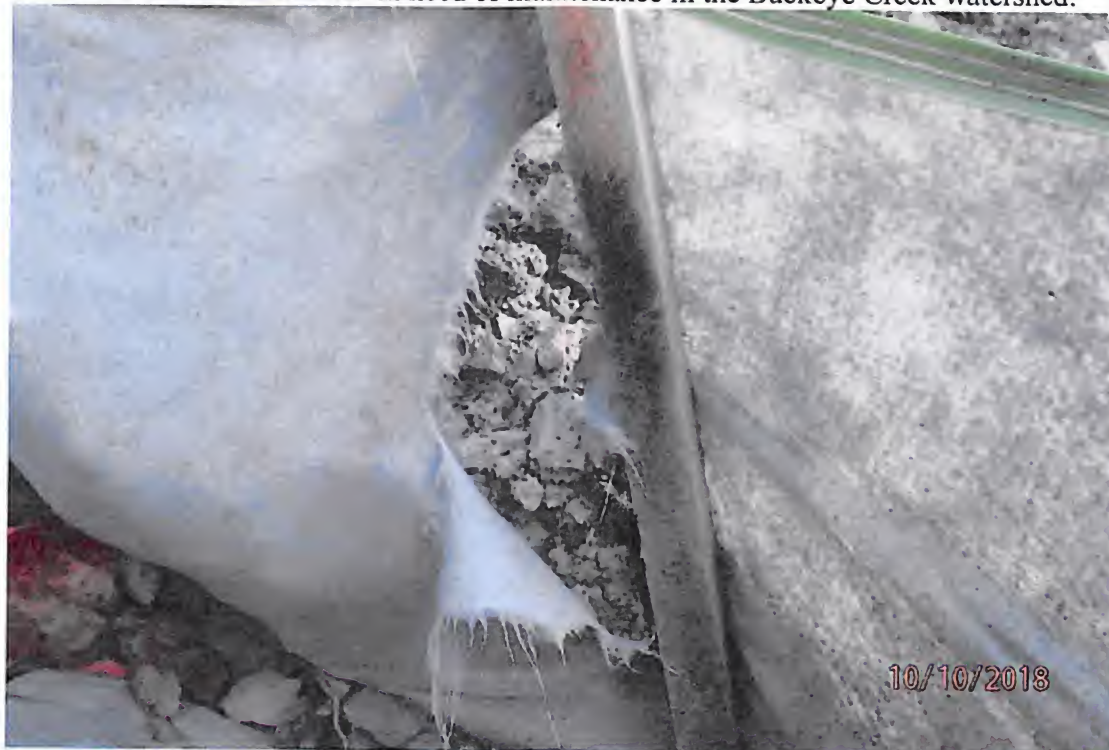
Perimeter control in need of maintenance in the Buckeye Creek watershed.

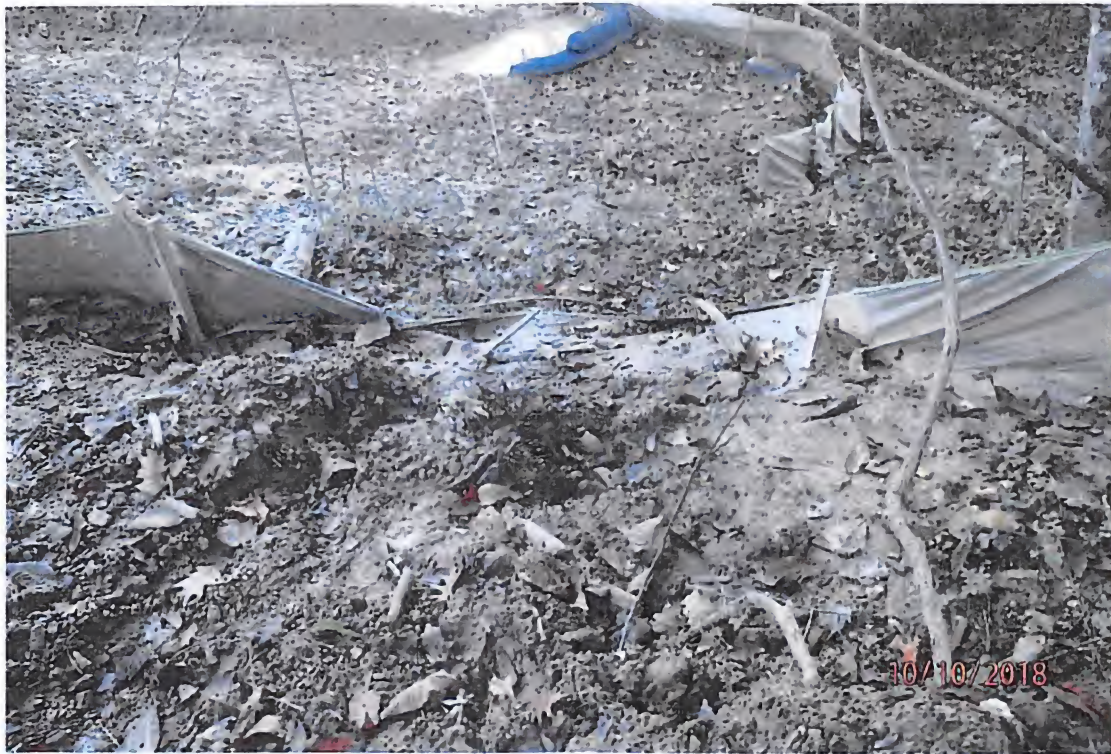
Perimeter control in need of maintenance in the Morgans Run watershed.

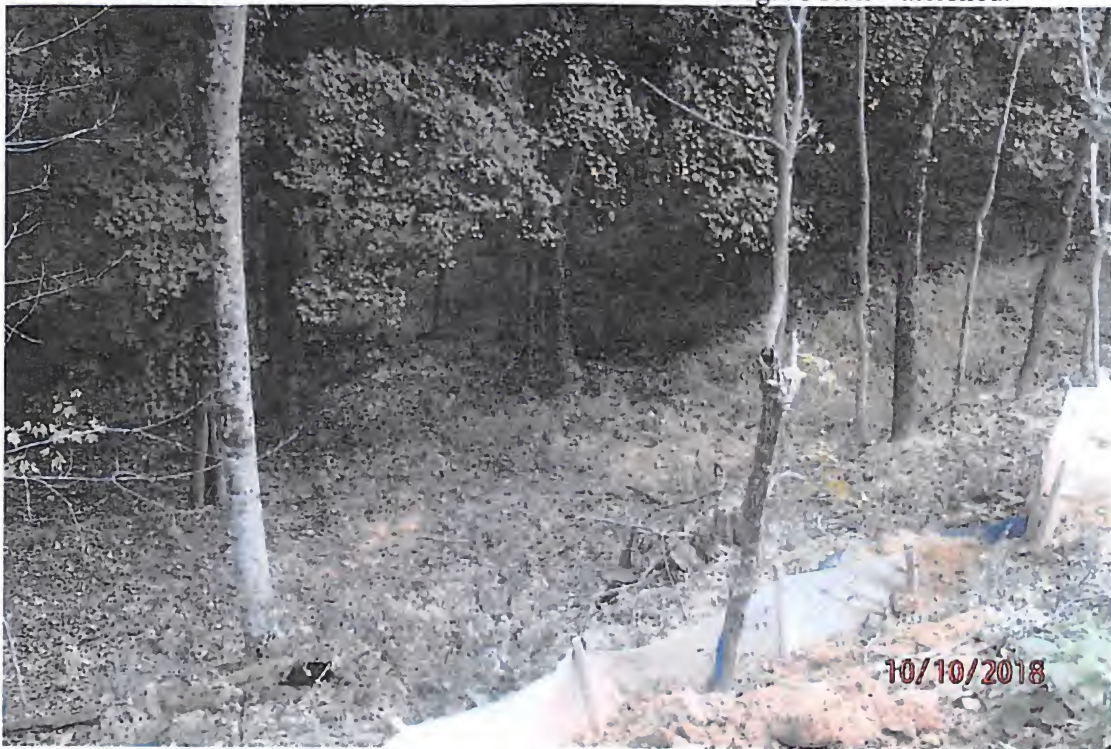
Water bar terminus BMP in need of maintenance and associated offsite sediment deposits in the Flint Run watershed.

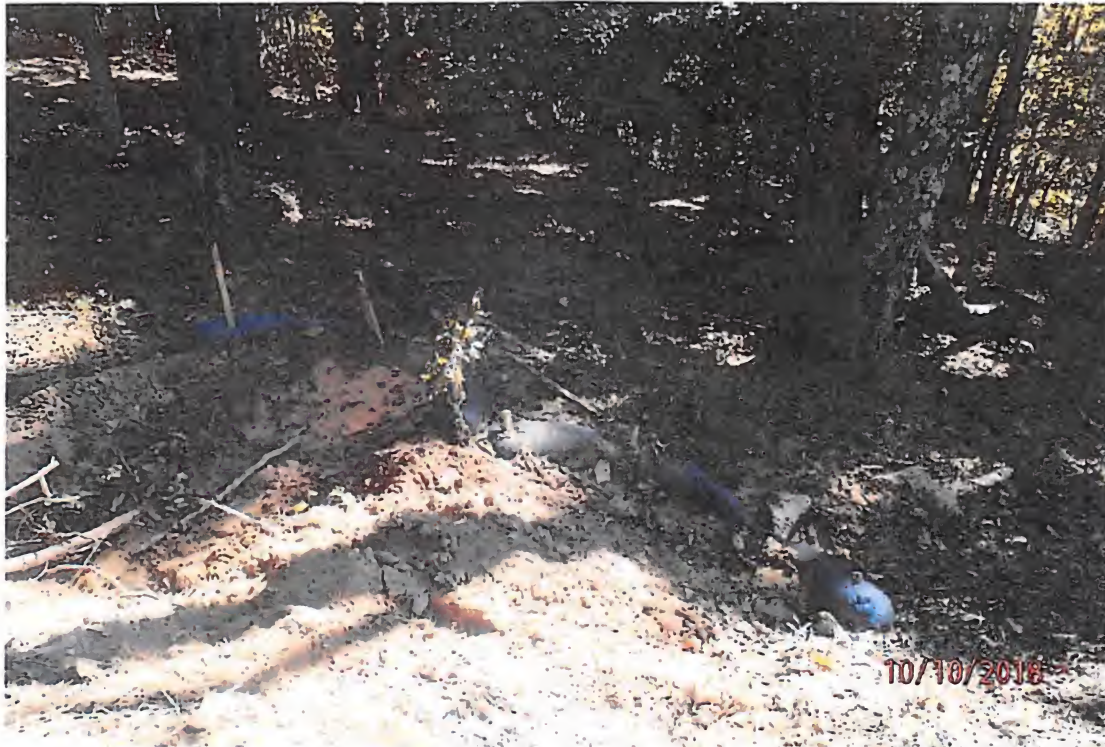
Water bar terminus BMP in need of maintenance adjacent to 153+00.

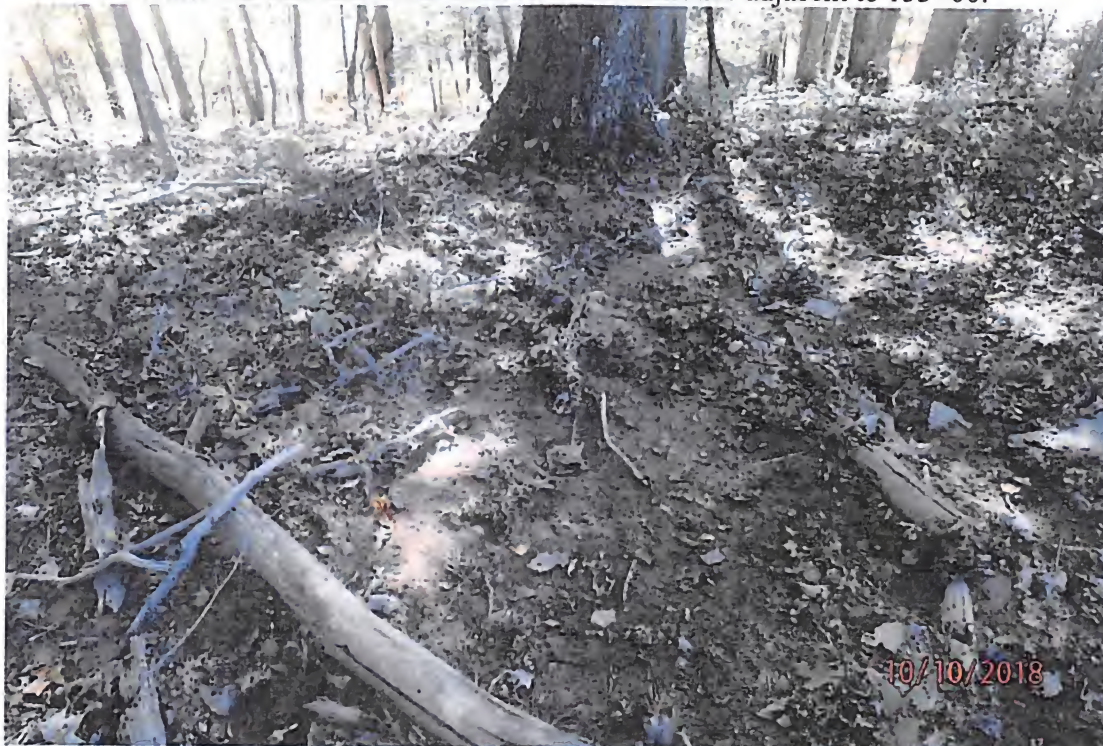
Offsite sediment deposits downslope of water bar terminus BMP adjacent to 153+00.

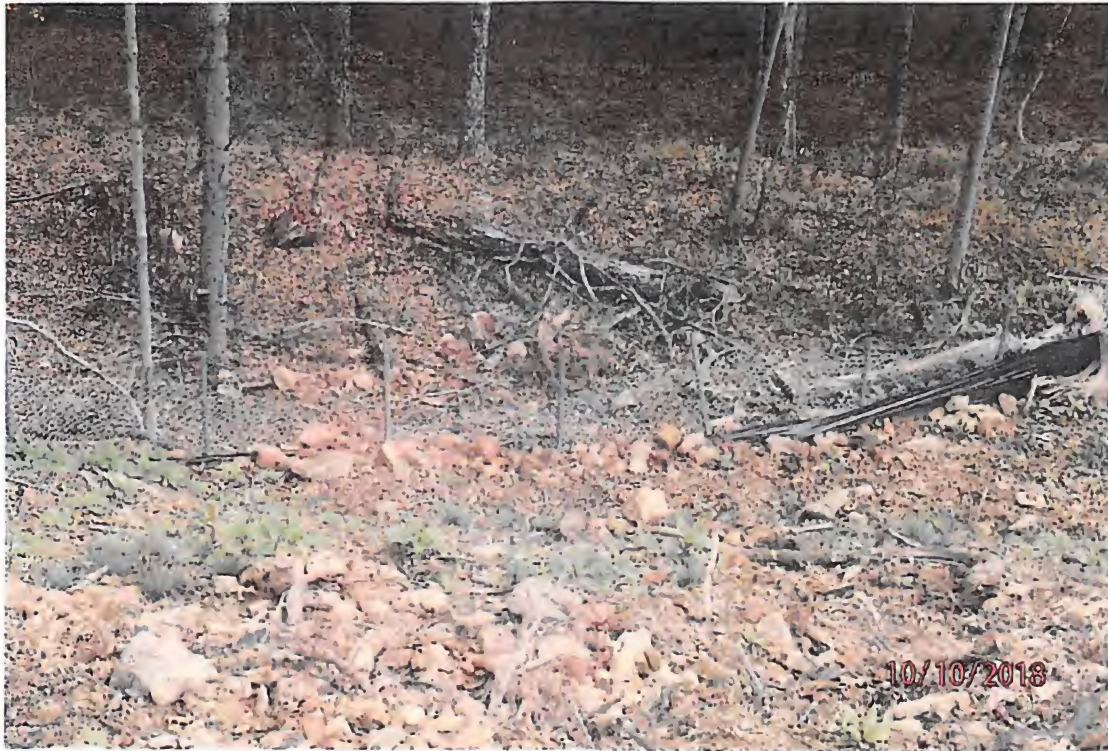
Perimeter control in need of maintenance in the Flint Run watershed.

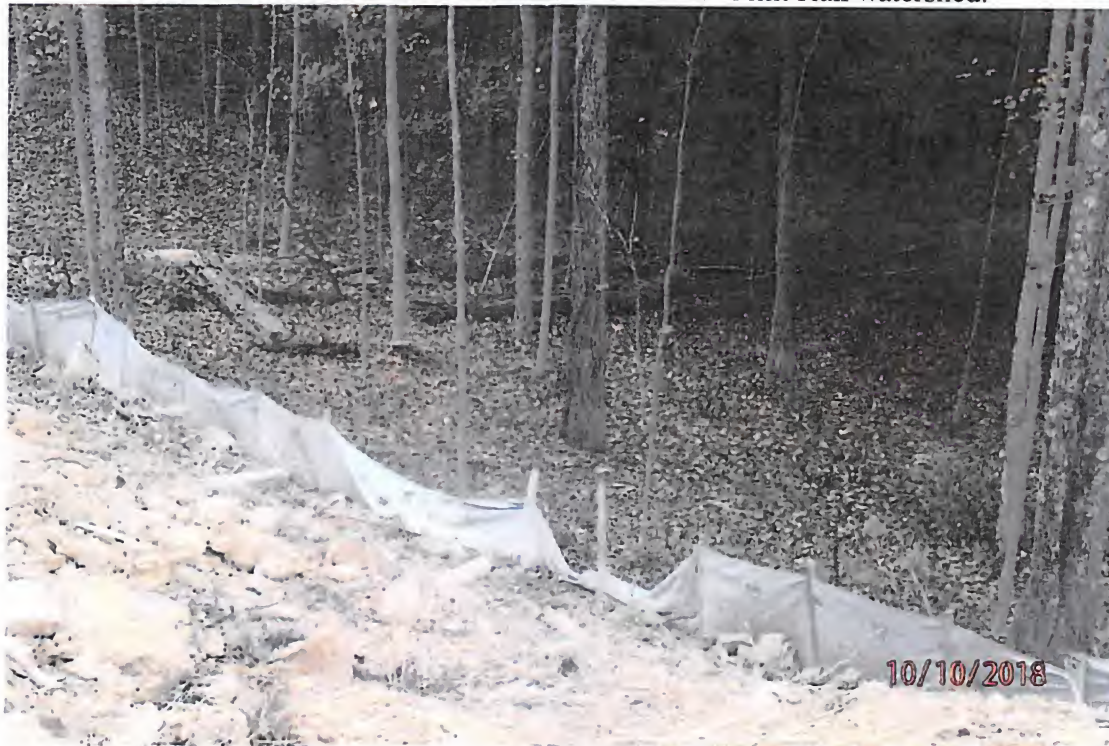
Perimeter control in need of maintenance in the Flint Run watershed.

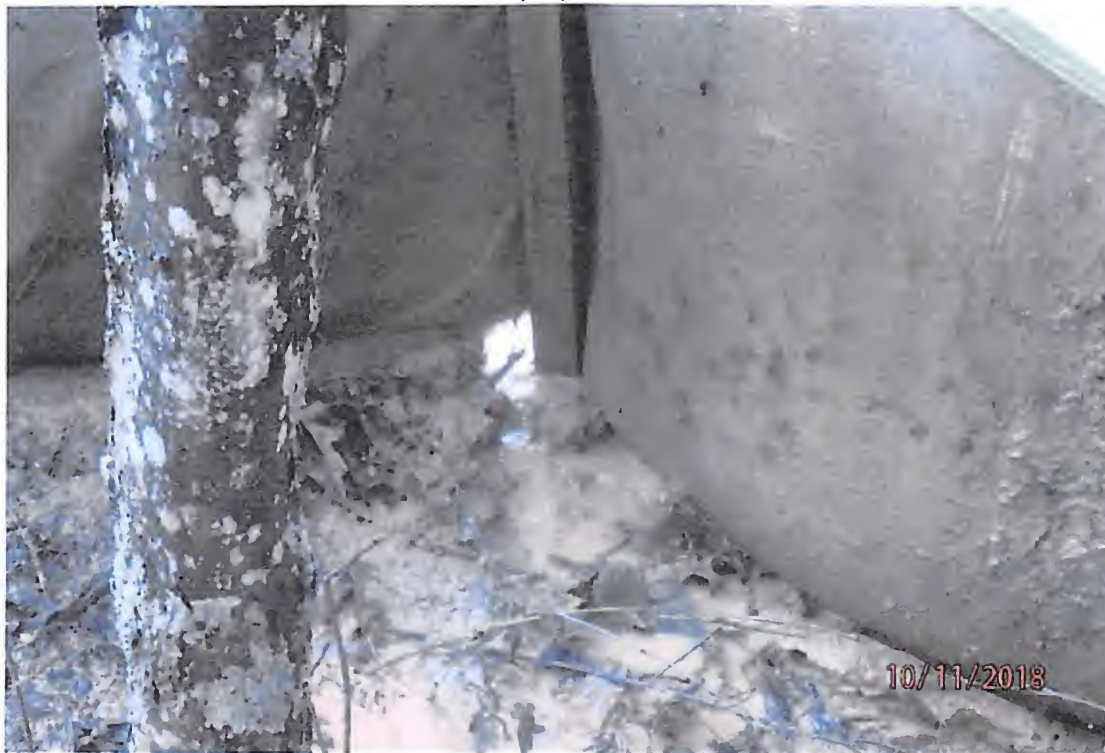
Sediment laden water passing through an unmaintained perimeter control adjacent to 872+00.

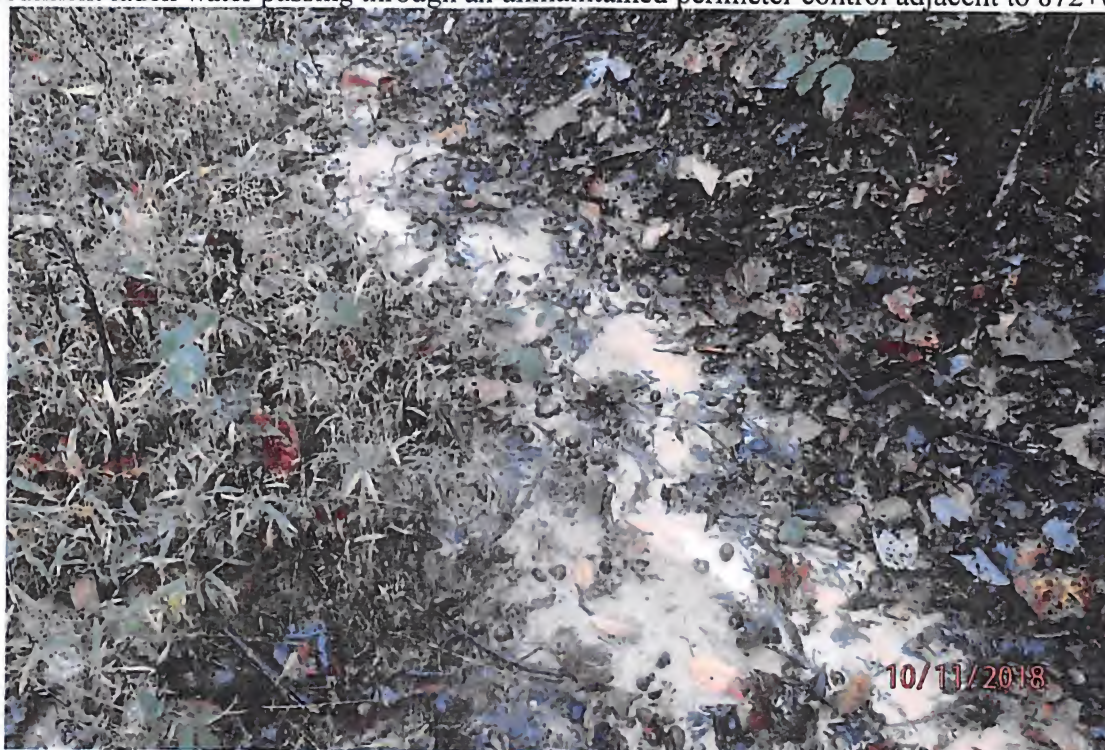
Offsite sediment deposits and sediment laden water that has bypassed the above pictured device adjacent to 872+00.

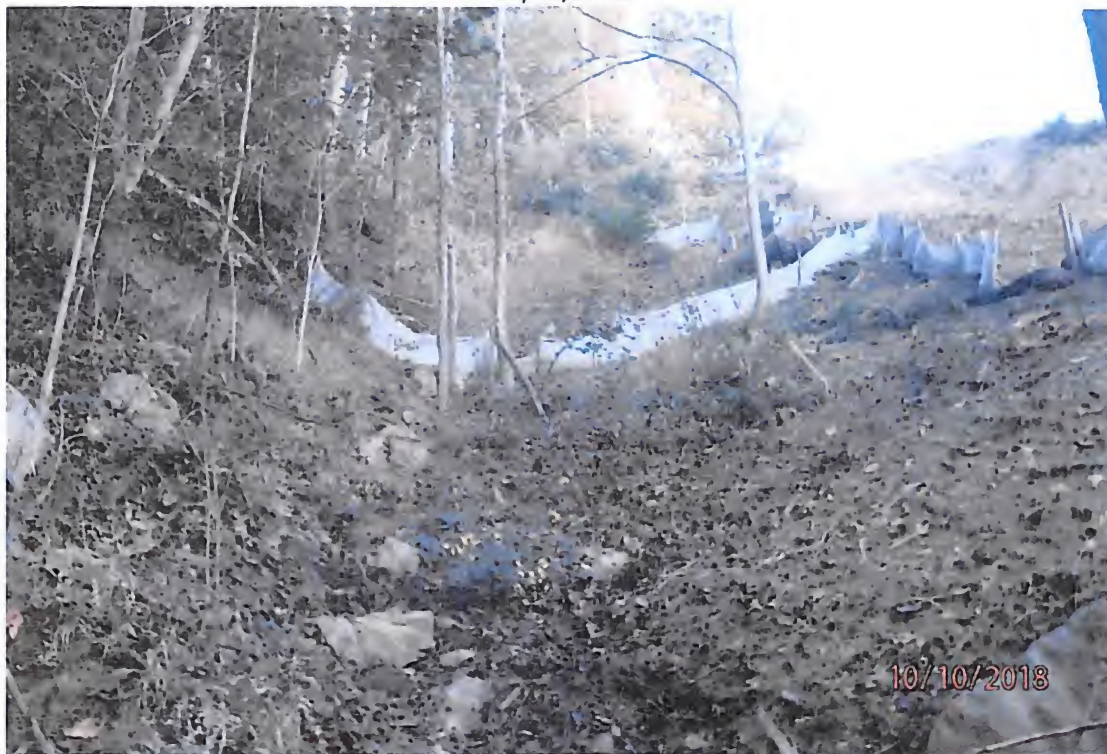
Overview of installed BMPs adjacent to UNT Buckeye Creek (UNT59).

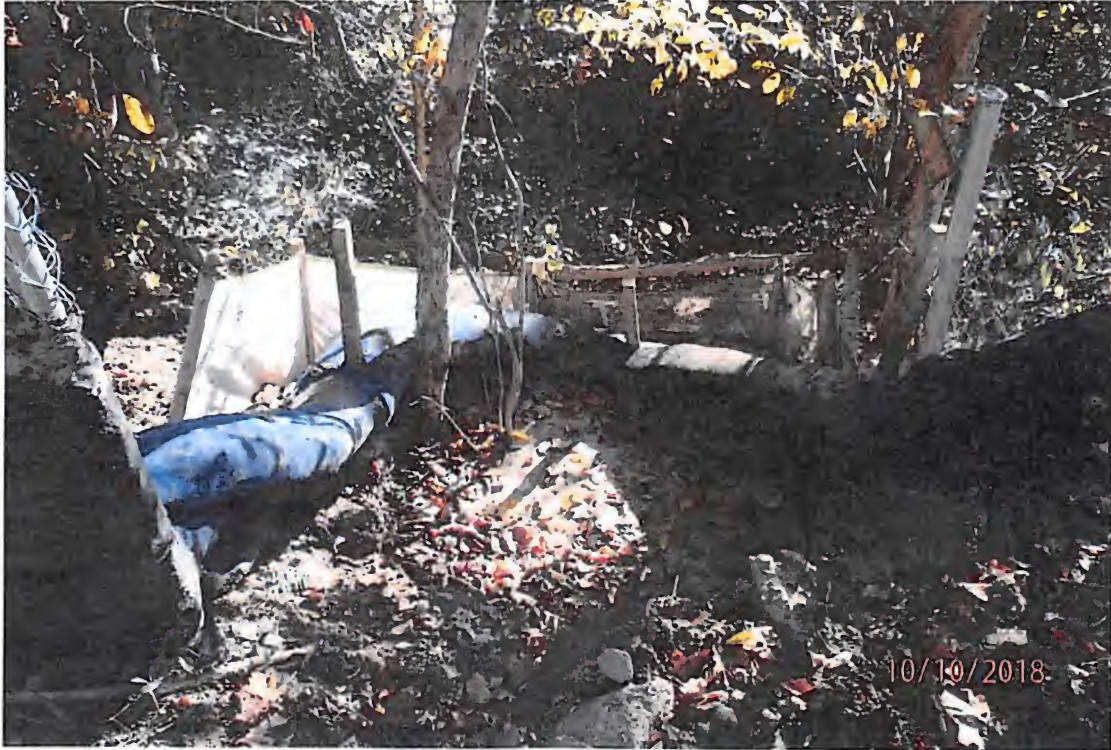
BMP adjacent to UNT Morgans Run that is in need of maintenance.

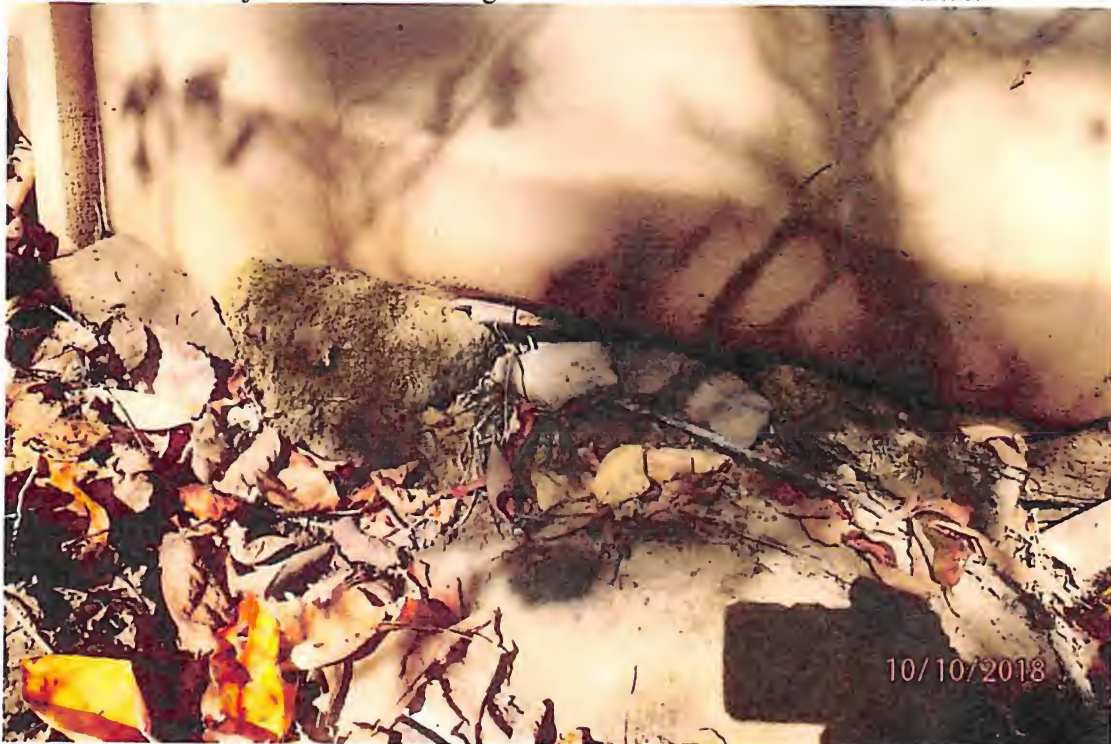
View of above pictured BMP from downslope showing rocks that are being utilized in an attempt to plug an area where sediment laden water is bypassing the BMP.

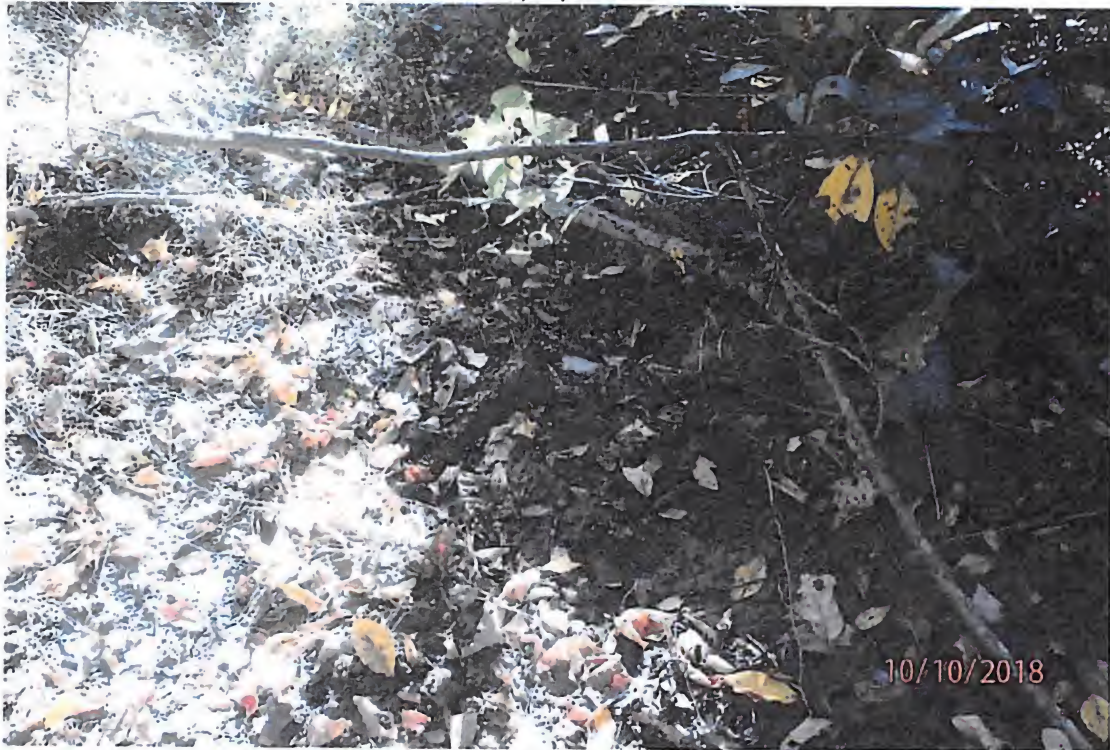
Offsite CNA deposits in UNT Morgans Run ($39^{\circ}17.640'$ X $80^{\circ}40.738'$) as a result of the previously pictured BMP.

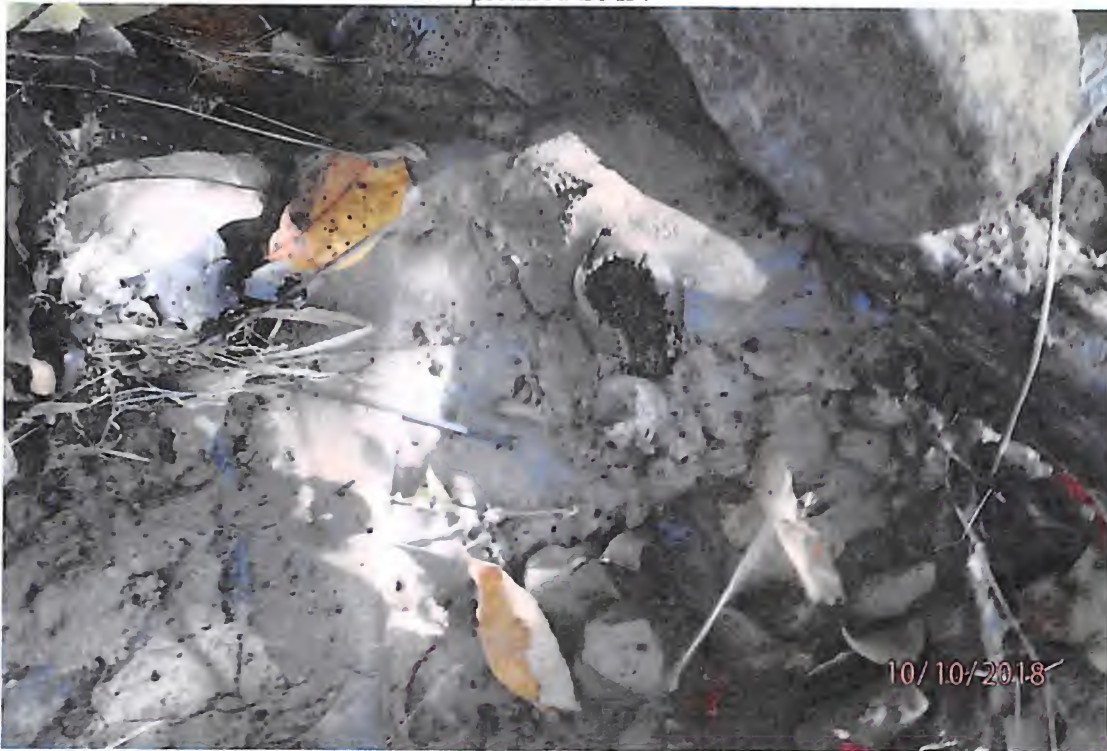
Offsite CNA deposits in UNT Morgans Run ($39^{\circ}17.640'$ X $80^{\circ}40.738'$) as a result of the previously pictured BMP.
